ATLAS Level-1 Calorimeter Trigger

CP ROD Test Status

A few more bits in the bucket

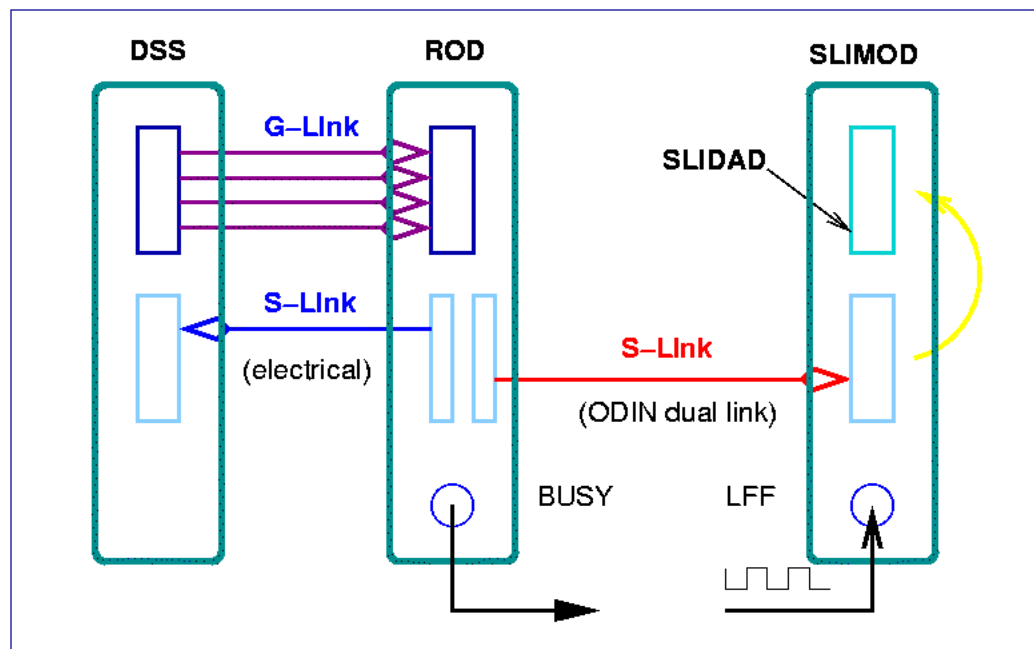
New Test Setups (1)

- Test for FIFO empty failure
 - due to flow control at high speed: LFF toggled at 0.5 MHz

- 2kHz event rate
- 2.4 million events (preliminary)
- no failures

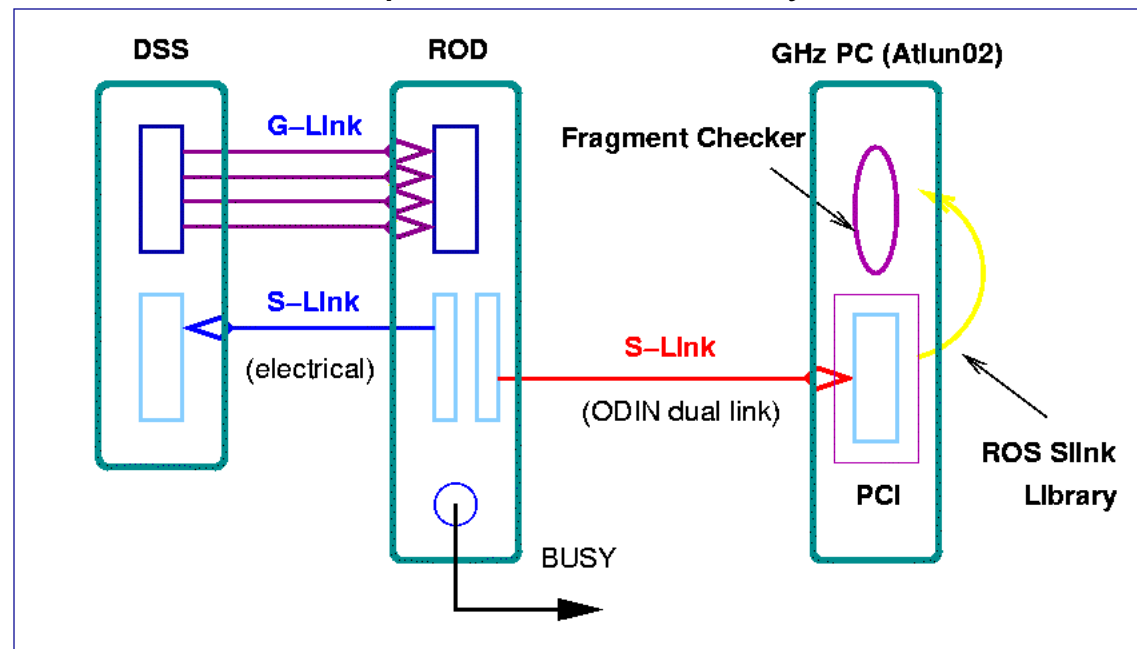
New Test Setups (2)

- Test for FIFO empty failure
 - due to flow control at lower speed: LFF driven by ODIN

- 6 khz event rate
- some million events (very preliminary)
- no FIFO failures
- bit errors?
