Observation of misaligned anode grids in production Vacuum Phototriodes

23 December 2004

B W Kennedy
Rutherford Appleton Laboratory

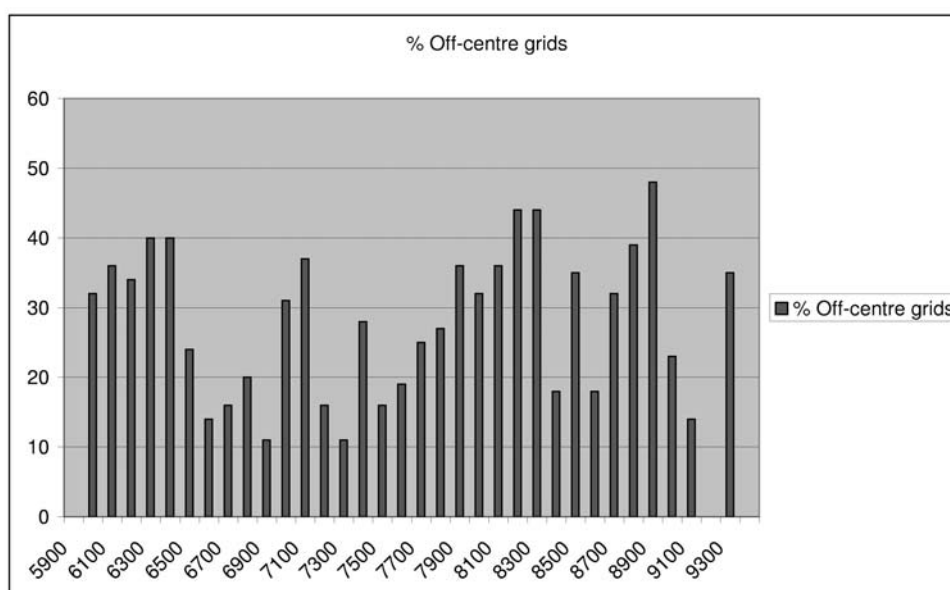
The percentage of tubes with grids significantly off-centre for VPTs with bar-codes from 6001 onwards is shown in Figure 1,. Each bin in the figure represents 100 VPTs. 27.2% of these VPTs have off-centre grids, but large fluctuations are seen over time. For example, the fraction was much lower for VPTs 6601-7600, but higher for devices in the ranges 6001-6500 and 8001-8400.

Figure 1. Fraction (%) of VPTs with significantly off-centre anode grids

However, since a misalignment of the grid will inevitably reduce the minimum clearance between components inside the tube, there may be an increased chance of electrical breakdown in the future. For this reason, we have concerns about the long-term behaviour of these VPTs, and would encourage RIE to take steps to improve the grid alignment. We will continue to monitor the affected VPTs, to obtain a better understanding of their long-term behaviour.
