## **Visual Inspection of VPTs**

B W Kennedy  
Rutherford Appleton Laboratory  
24 January 2002

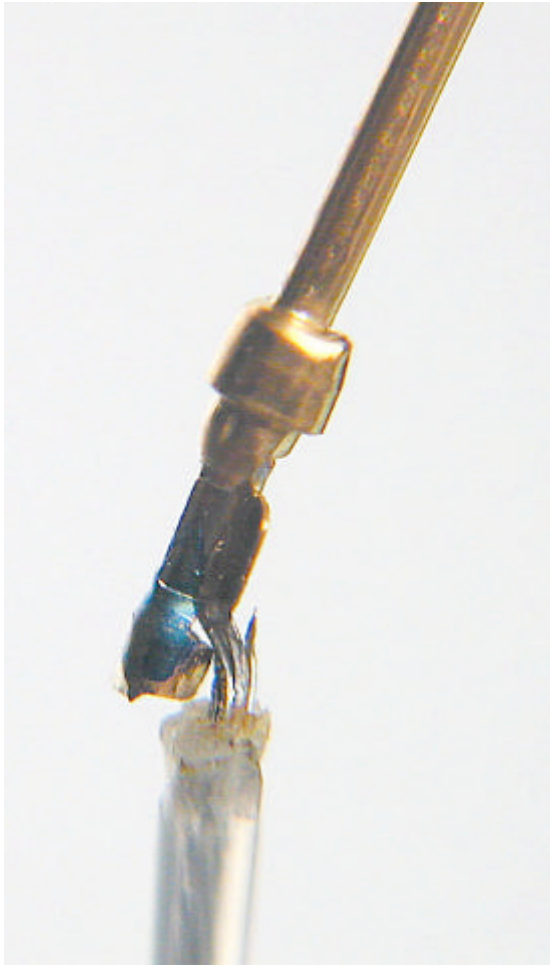
1. The pins are poorly crimped onto the flying leads – some pins have already become detached in the course of testing. These pins will be plugged and unplugged several times during the VPT testing procedures, so it is essential that they are securely attached to the leads.

In addition, the insulation appears to have been thermally stripped in order to prepare for the pin. The insulation has not been cleanly removed on many crimps.

**Figure 1. VPT 539 - poor crimping of pin to flying lead**

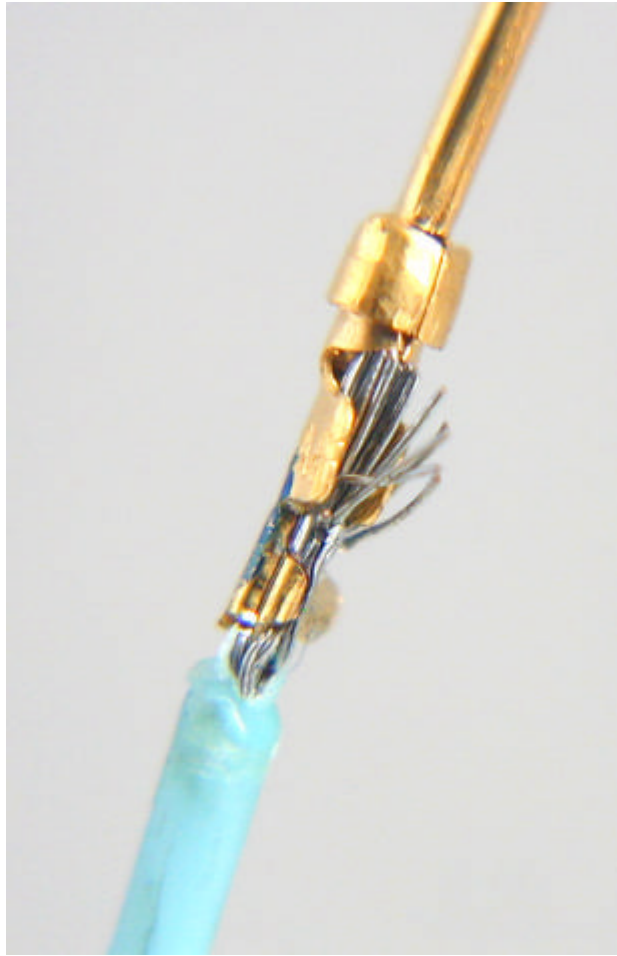
**Figure 2. VPT 560 - poor crimping of pin to flying lead**

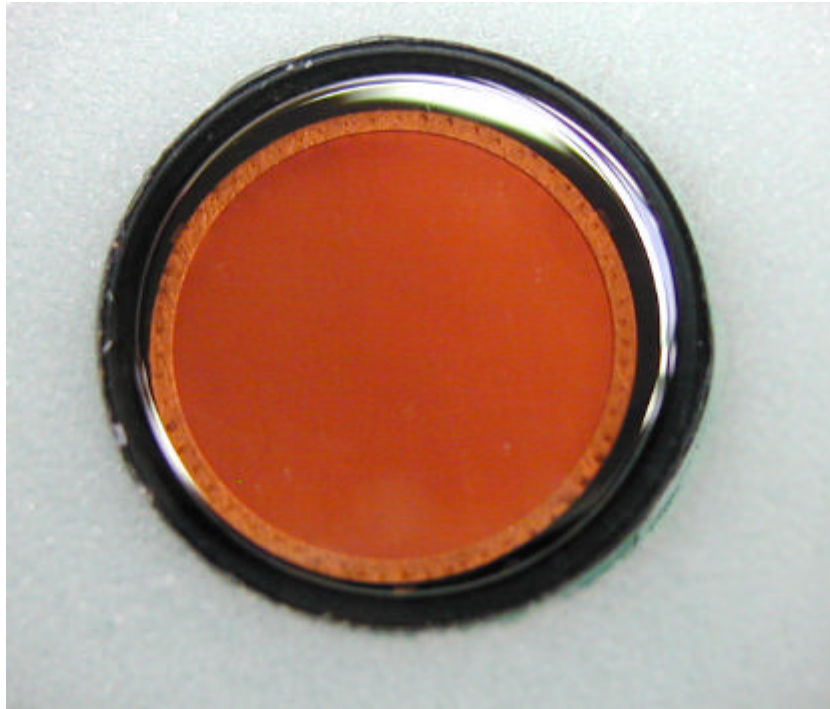
2. A few of the VPTs have their grids significantly off-centre with respect to the axis of the cylinder. We would like to return these badly off centre devices to you. Figure 4 and Figure 5 show examples of misaligned grids.

**Figure 4. VPT 556 - grid misaligned.**

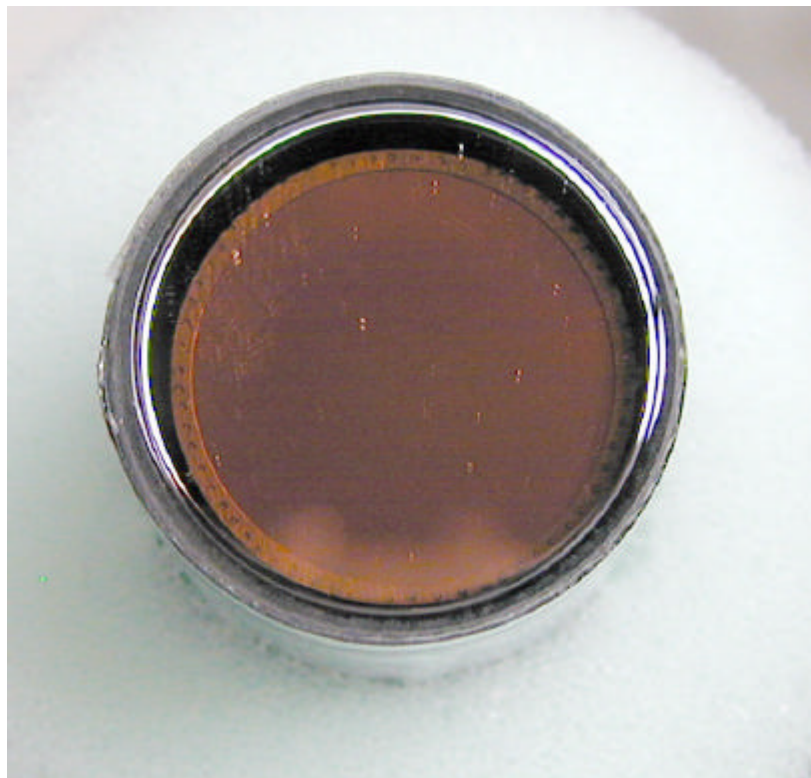
**Figure 5. VPT 570 - grid misaligned**
