ATLAS Level-1 Calorimeter Trigger

CP ROD Test Status

A few more bits in the bucket

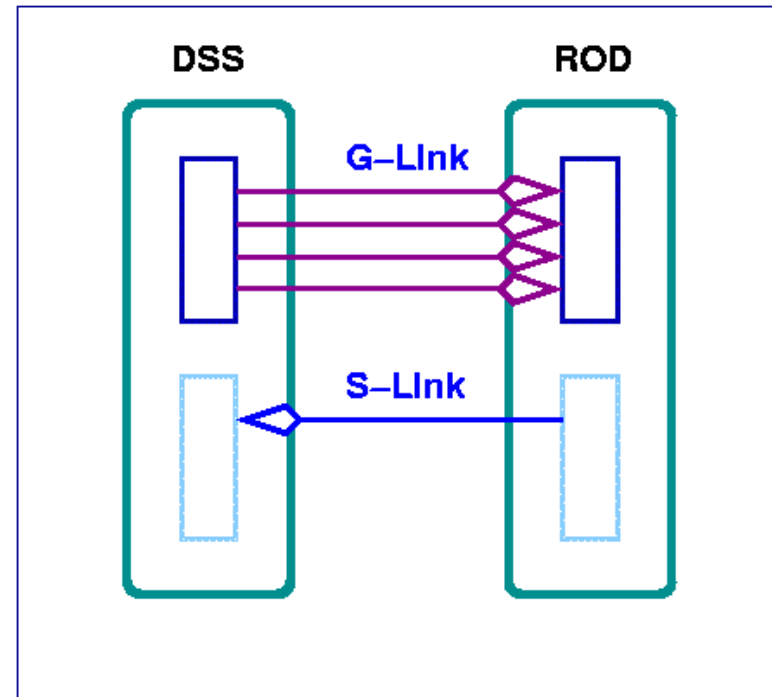
Standard Test Setup

- Single DSS, ROD loop
 - L1As in bursts distributed through TTC system
 - Appropriate for testing ROD (slice or RoI mode) in absence of external interfaces (RoIBuilder)
 - Fast Flow (normally no LFF applied)
