## **Visual Inspection of VPTs**

B W Kennedy  
Rutherford Appleton Laboratory  
24 January 2002

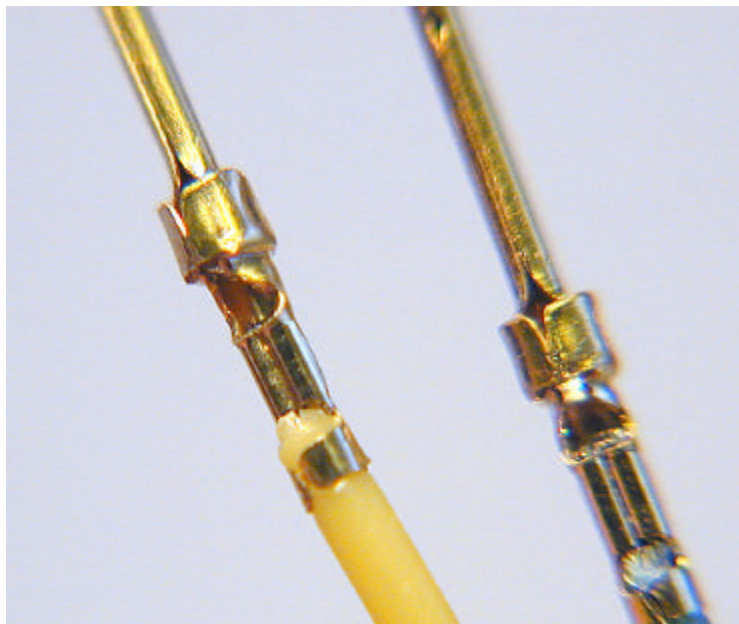
1. The pins are poorly crimped onto the flying leads – some pins have already become detached in the course of testing. These pins will be plugged and unplugged several times during the VPT testing procedures, so it is essential that they are securely attached to the leads.

In addition, the insulation appears to have been thermally stripped in order to prepare for the pin. The insulation has not been cleanly removed on many crimps.

**Figure 2. VPT 560 - poor crimping of pin to flying lead**
