# CPM testing: Glinks, DAQ and RoI

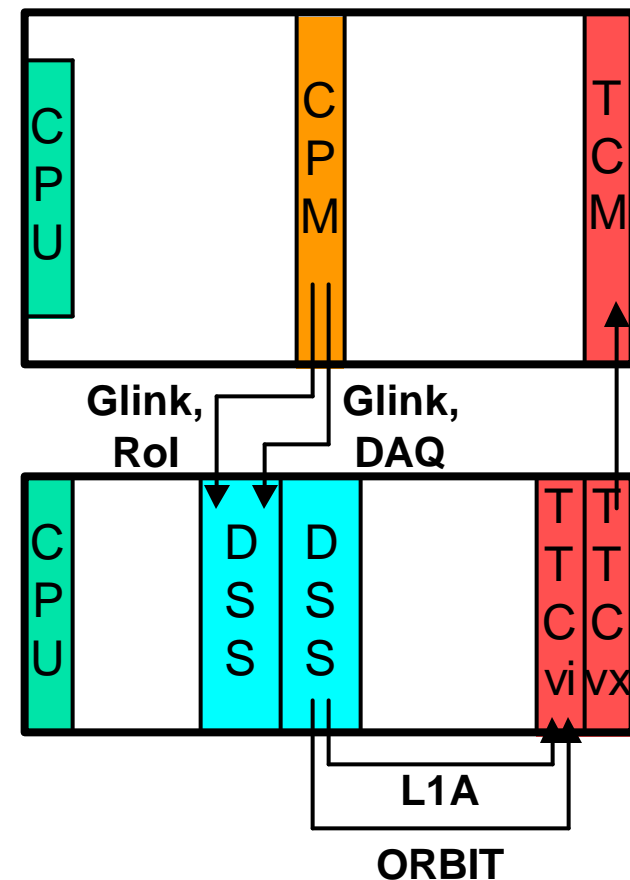
# Birmingham Test Setup

- o DSS (Glink/ECL variant)
  - o Produces L1A and ORBIT
  - o Connected directly into TTCvi
- o TTCvi/TTCvx
  - o Programmed to use external trigger and orbit
  - o Also program B channel 0 to produce BC-reset
- o CPM
  - o Serialiser playback data
  - o (Could also use LVDS DSS)
- o DSS (Glink sink variant)
  - o Accepts any Glink packet
    - o CPM DAQ or RoI
    - o Also tried CMM briefly
  - o Filling controlled by software
  - o Has some advantages over using ROD
