# GLINK DAV GAP requirement of ROD f/w

Weiming Qian  
UK Meeting, RAL  
06/02/2004

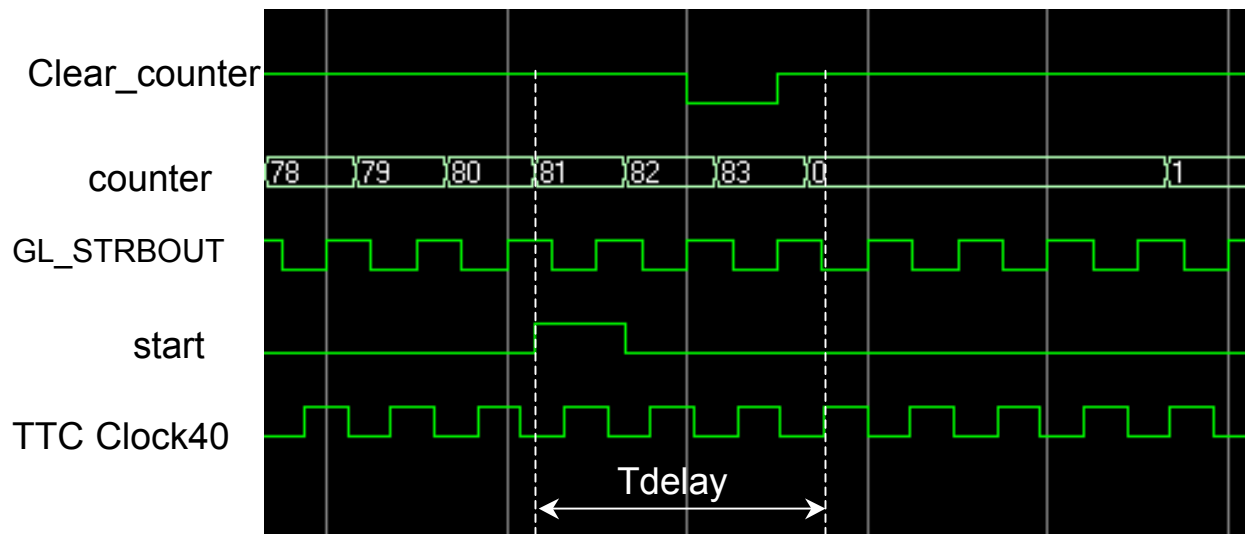
# Clock domains

$2 \text{ ticks of GL\_STRBOUT} < 3 \text{ ticks of clock40} < \mathbf{Tdelay} < 4 \text{ ticks of clock40} < 5 \text{ ticks of GL\_STRBOUT}$

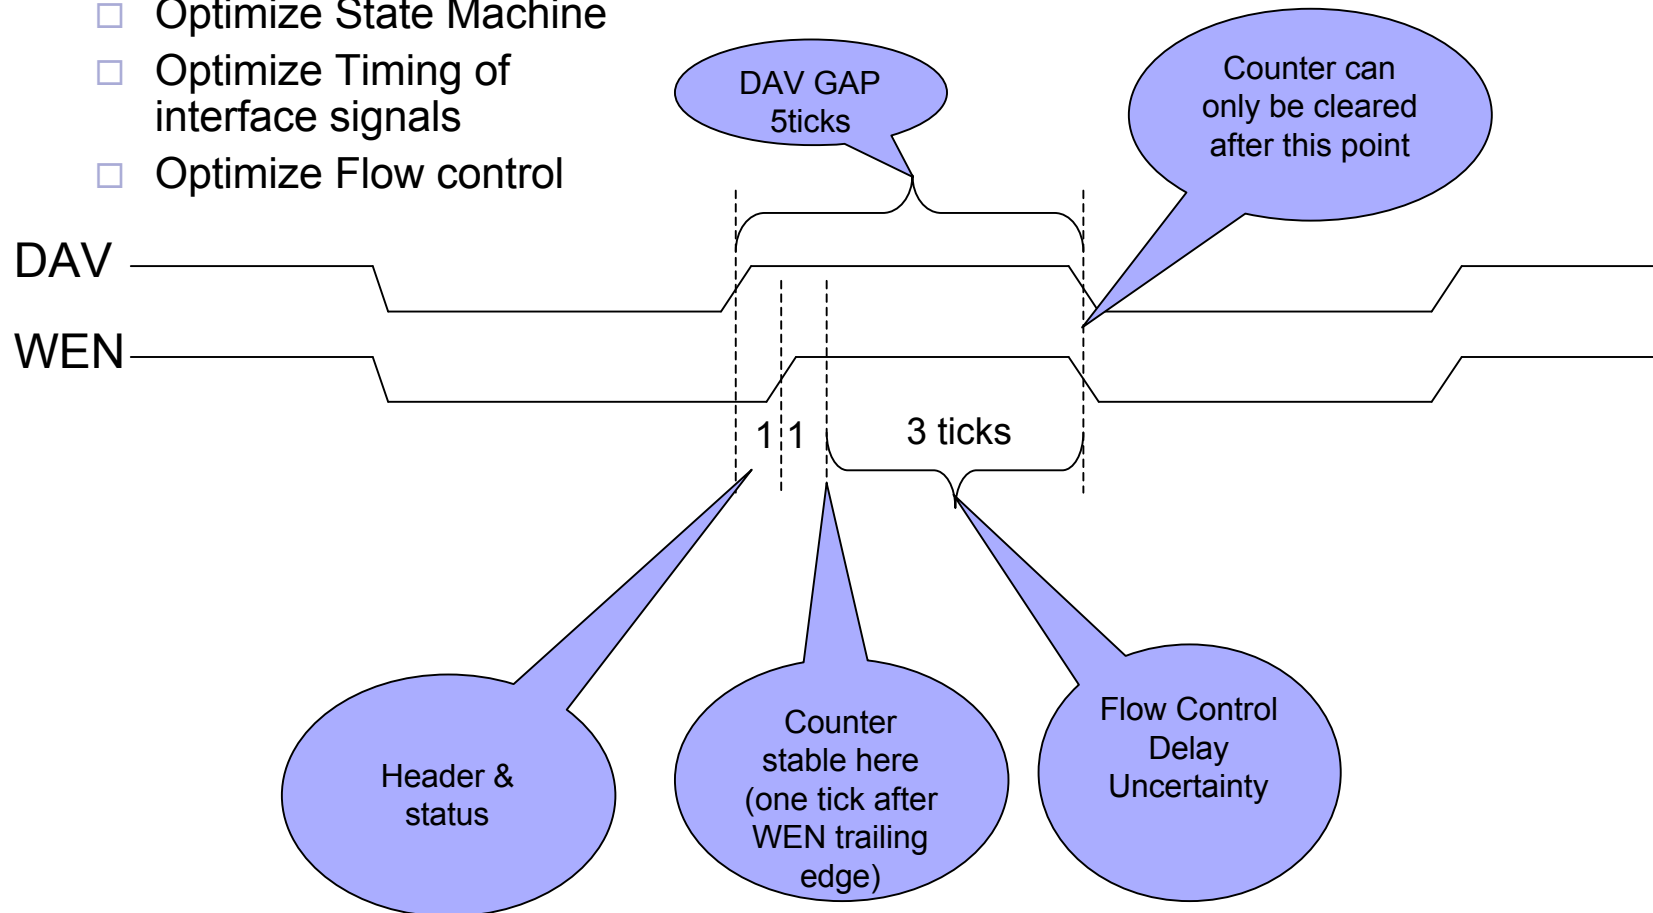
# Minimum DAV GAP for CPM slice data

- Minimize the DAV GAP
  - Optimize State Machine
  - Optimize Timing of interface signals
  - Optimize Flow control

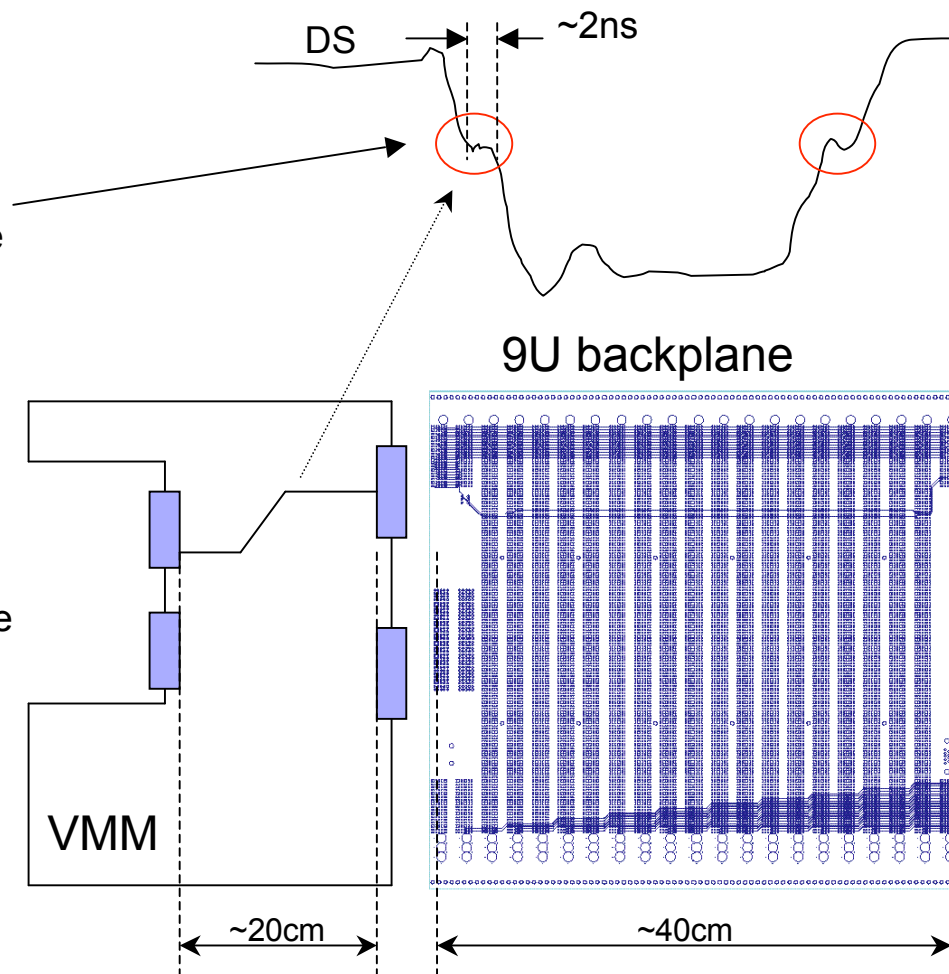
# VMM signal quality

- VME -- signal integrity problem
  - Edges of DS is not good
  - Small step within input transition area of TTL gate
  - Might cause double latch

- Signal traces on VMM
  - Over 20cm
  - Impedance not controlled
  - Impedance on VMM can **NOT** match the impedance on backplane anyway
    - Due to load effect on backplane
    - Bare backplane impedance ~50ohms

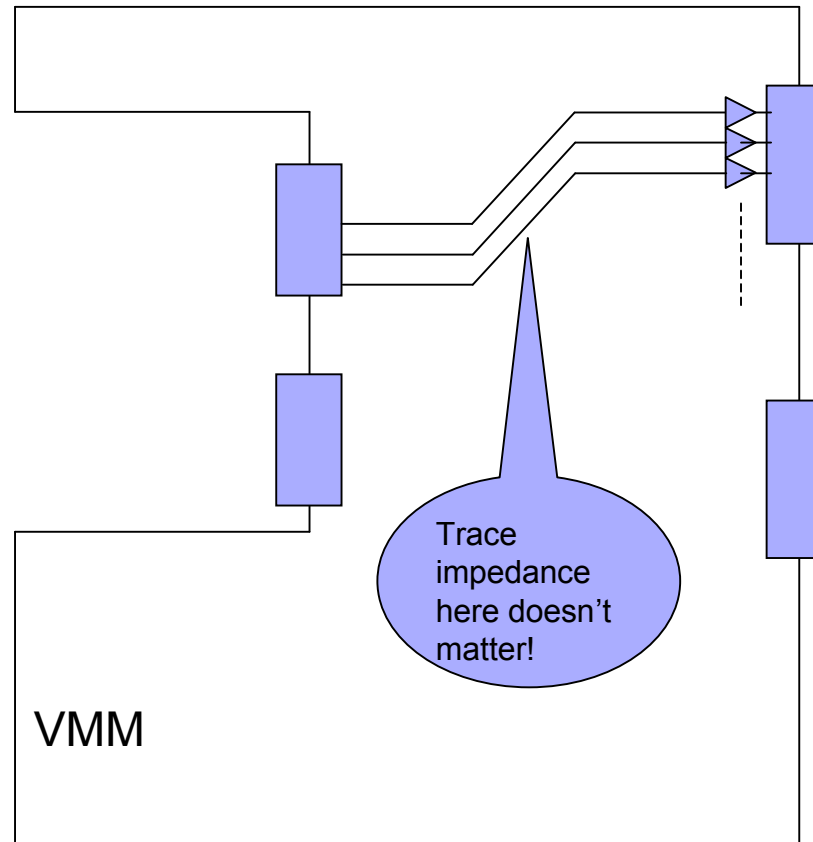
# VMM proposals

- Add buffers near backplane connector
  - DS
  - A01 — A23
  - DTACK
  - WRITE
  - SYSRESET
  - Possible for D00 -- D15
- Choose slower buffers
  - 74LS series instead of 74F series
  - Slower but smooth edge is better than faster but glitch edge
- Remove termination on VMM side
  - DS
  - A01 — A23
  - WRITE
  - SYSRESET
