# Cluster Processor Modules Testing

Uk Meeting, Tuesday the 27<sup>th</sup> of April 2004

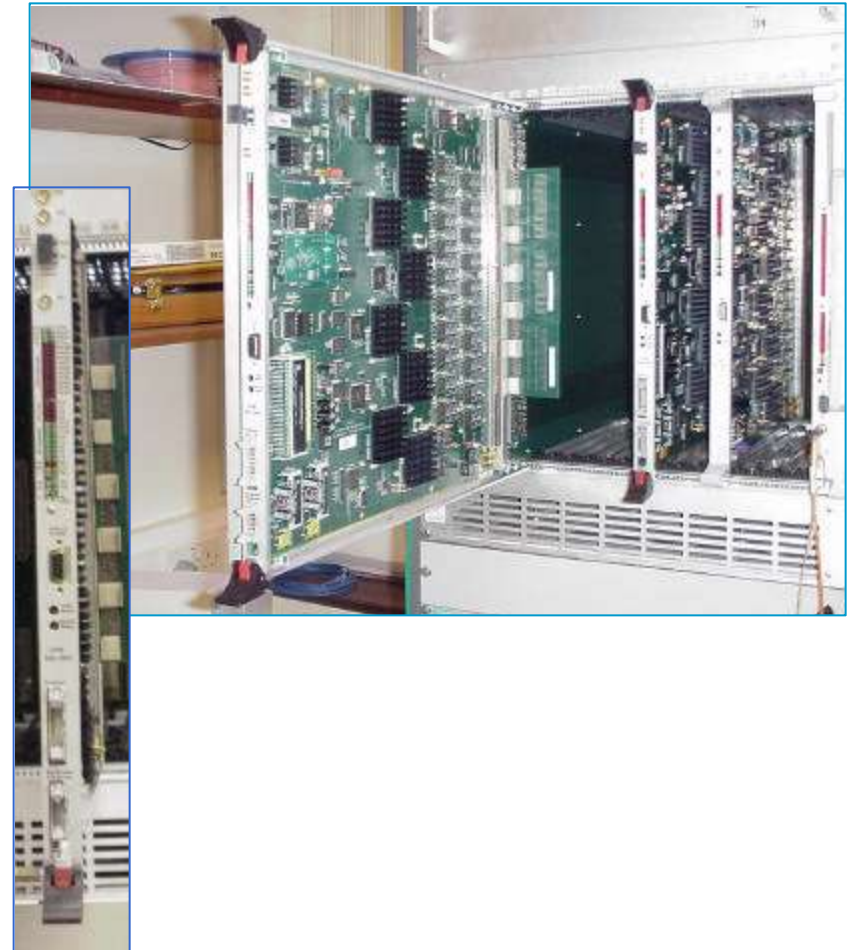
# Two New CPM have arrived: CPM1.5

New facilities:

- n Extra clock on CP chips
- n JTAG access on the front panel
- n Test-points on the front panel
- n Optical output
- n Extra Leds
- n Better handles
