Behaviour of production VPTs for the CMS Endcap Electromagnetic Calorimeter: VPTs 501-10400

22 April 2005

Abstract

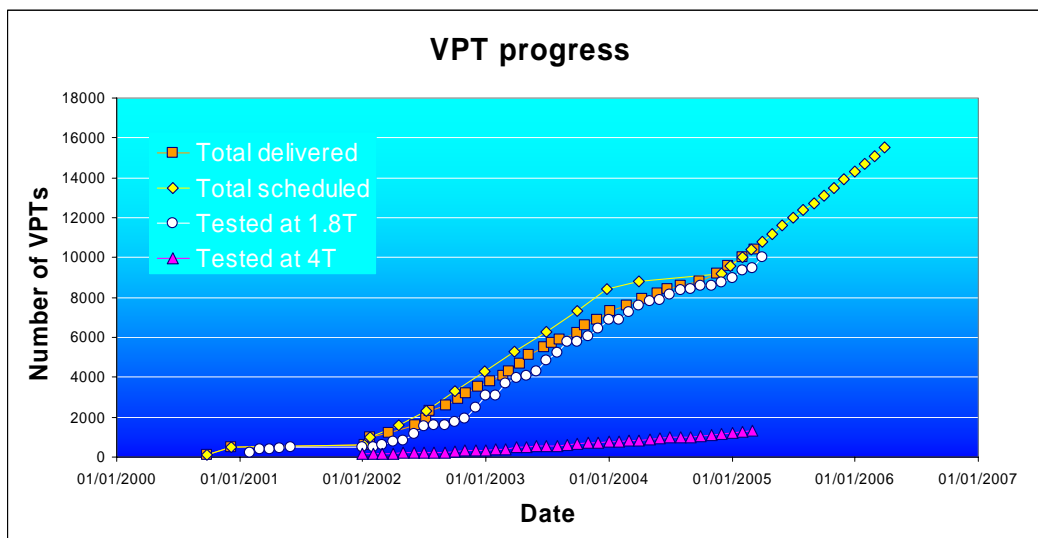
Figure 1. VPT delivery and testing

Figure 1 shows the VPT delivery rate as a function of time from 25 September 2000 to the present. The current delivery rate is in agreement with the revised schedule.

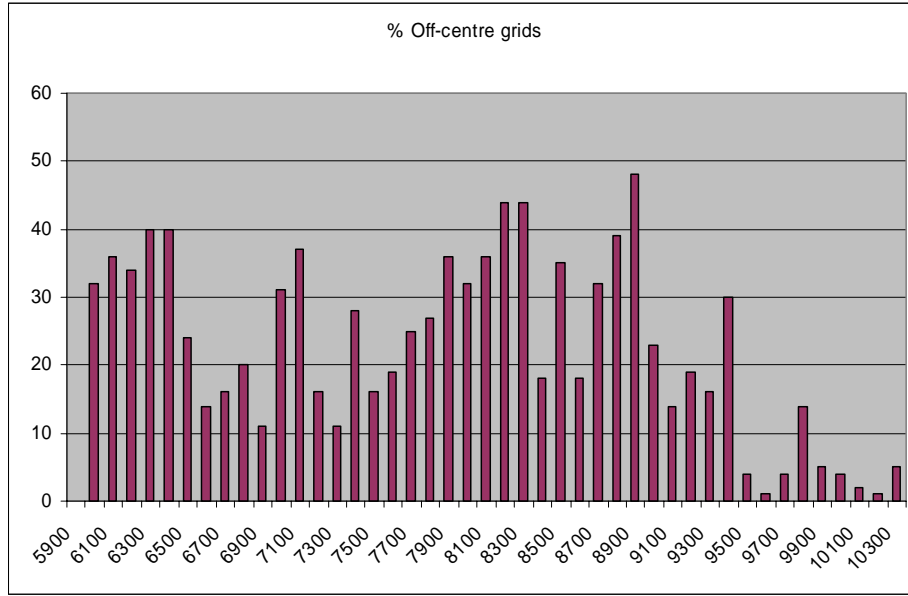
Figure 2. Fraction of VPTs with off-centre anode grids as a function of bar-code

The feature which is most often seen is a misalignment of the anode grid with respect to the axis of the VPT. Over 20% of the VPTs appear to have some misalignment of the grid, though this rate has been reduced to about 3% for VPTs with bar-codes above 9600. The operation of these VPTs seems to be unaffected by the grid position: however, this aspect of the VPT appearance will continue to be monitored at RAL. The fraction of VPTs with off-centre grids is shown as a function of bar-code in Figure 2.

VPTs with bar codes from 5901 to 8600 showed an increased frequency of photocathode defects, and of unsatisfactory crimping of pins to the leads, but in more recent batches both these problems have been greatly reduced. The alignment of the anode grids has been significantly improved in VPTs from 9601 onwards.

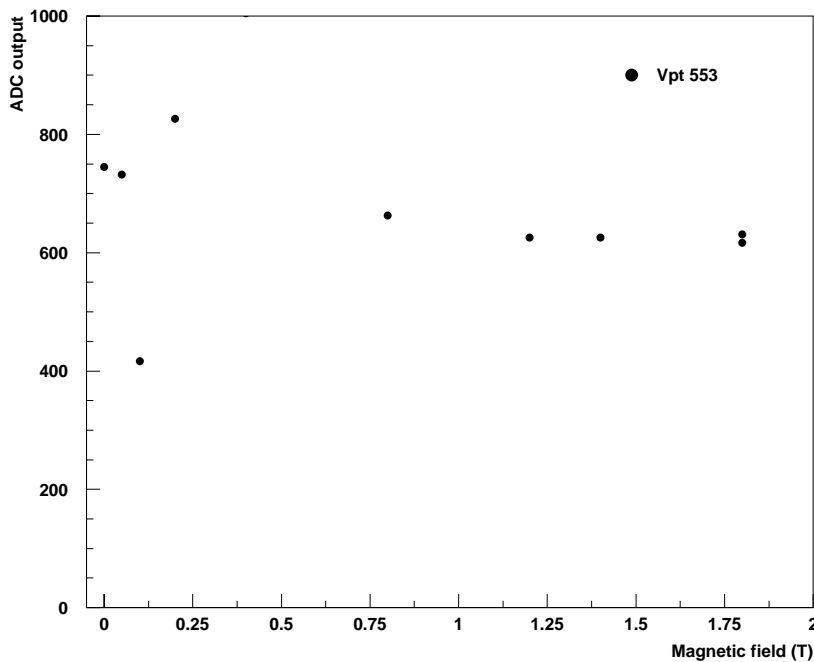
Figure 3. Examples of magnetic field scan on a typical VPT

The RAL test rig allows VPTs to be operated at any magnetic field up to 1.8T. A standard part of the testing procedure is to scan the field from 1.8T to 0T with the VPT held at an angle of 15° to the field. After each change of field, a short settling period of about 2 minutes is allowed to ensure that the magnet and the VPTs are stable before starting to pulse the LEDs. 5000 LED pulses are measured at each field point, at a rate of approximately 150Hz. Figure 3 shows the variation in output with field for a typical VPT.

The VPT in this figure (bar code 553) exhibits a significant instability in the anode pulse size at low field. The pulse width also increases substantially in this field range. Many VPTs display similar behaviour at fields below 1T; a minority are unstable at 1.8T, and have been analysed in a separate report [3].

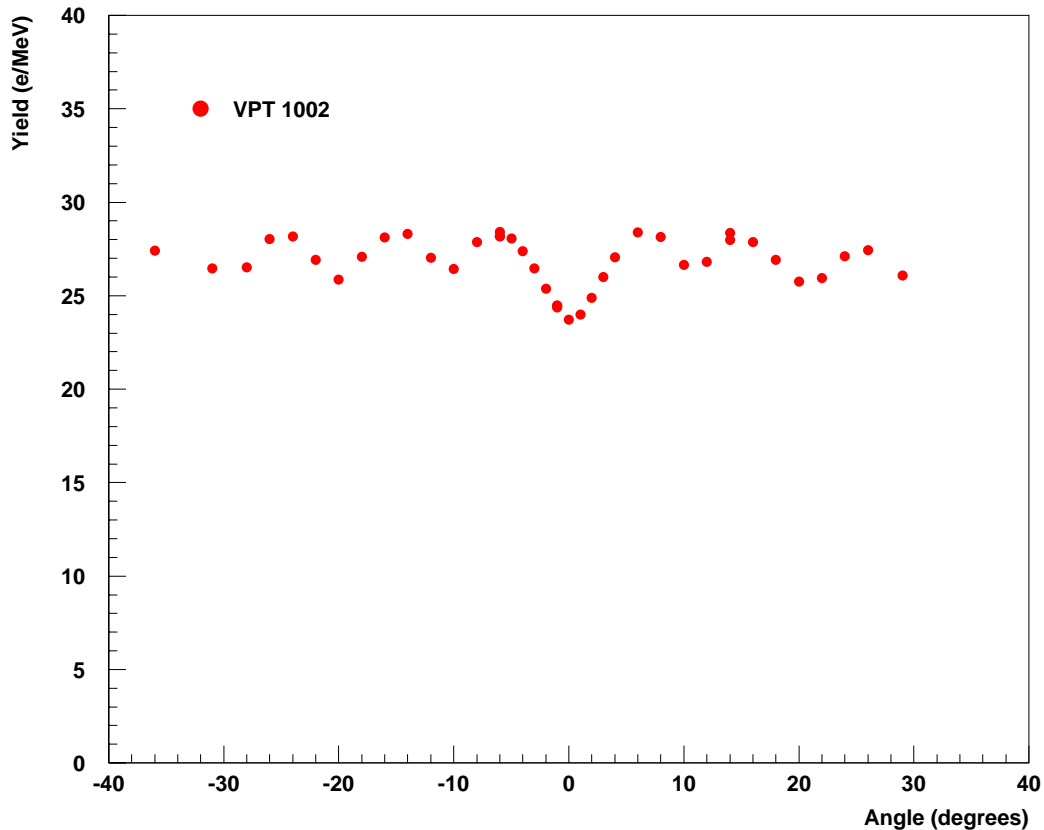
Figure 4. Angular scan at 1.8T on a typical VPT

angle with respect to the 1.8T field. In the standard angle scan, measurements are taken at angles from 30° to -35°; after every movement, a short settling period is allowed so that any induced instabilities in the VPTs can decay before taking data. Again, each measurement consists of 5000 LED pulses. Figure 4 shows the variation in output with angle for a typical VPT.

The periodicity shown in this figure is seen in all of the VPTs supplied by RIE, and is dependent on the alignment of the anode grid with respect to the axis of rotation. The orientation of all the grids has been determined at RAL, and in the standard measurement procedure the grid lines are aligned with the axis of rotation.

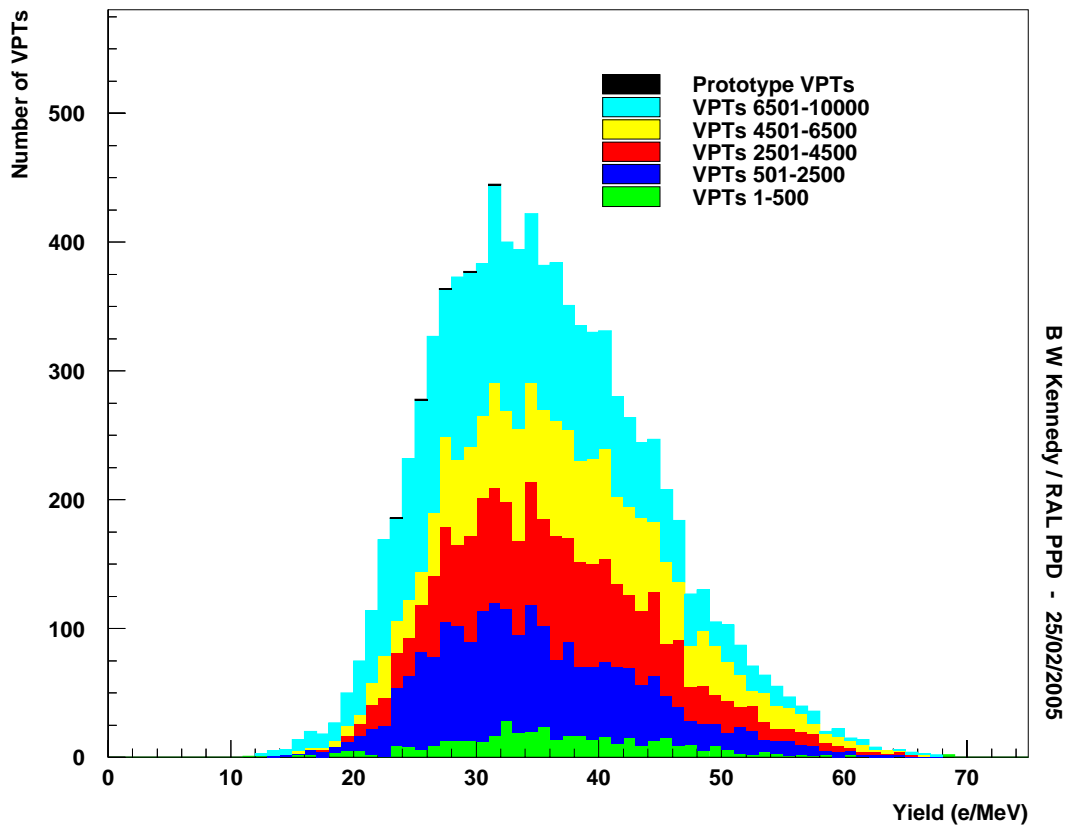
Figure 5. Mean anode pulse height over the angular range 8° - 25° in a 1.8T magnetic field

8100 of the production tubes have so far been tested in the RAL test rig. Figure 5 shows the distribution of anode pulse heights measured in a 1.8T magnetic field; the quantity

plotted is the mean pulse height over the angular range 8° - 25° to the magnetic field. For comparison, results obtained from the pre-production batch are also shown. The measured pulse heights have been converted into the expected experimental yield of electrons per MeV of energy deposited in the CMS calorimeter.

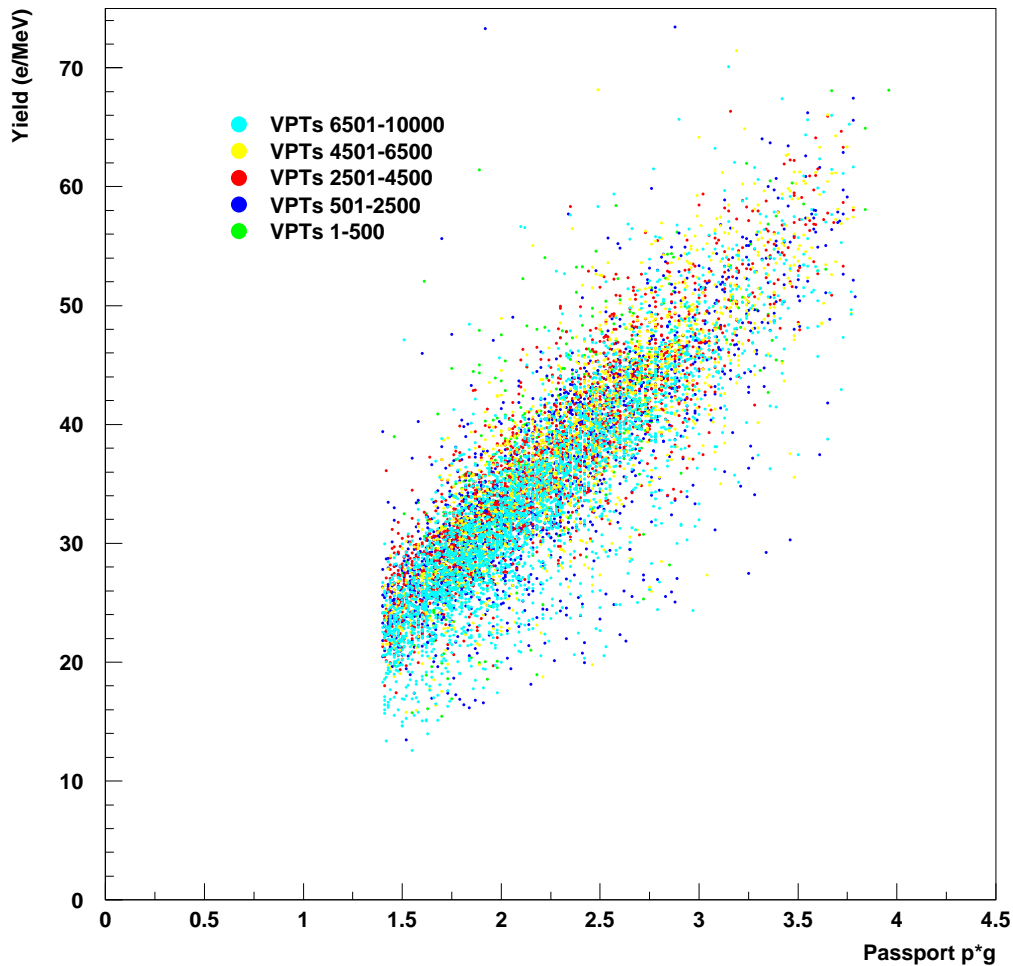
Figure 6. VPT response at 8°-25° and 1.8T v quality factor PG

Figure 6 shows the correlation between the mean pulse height in the 1.8T magnetic field and the quality factor PG supplied by the manufacturer. The correlation between the manufacturer's measurements at 0T and the RAL measurements at 1.8T is striking.

The first 9900 production VPTs supplied by RIE have been subjected to a variety of measurements at RAL and Brunel University. The parameters supplied in the VPT passport are found to correlate well with these measurements.
